nextTM

Template Assisted Crystallization

A No Salt, No Chemical, Non-
Backwashing, Zero-Discharge
Alternative to Softening

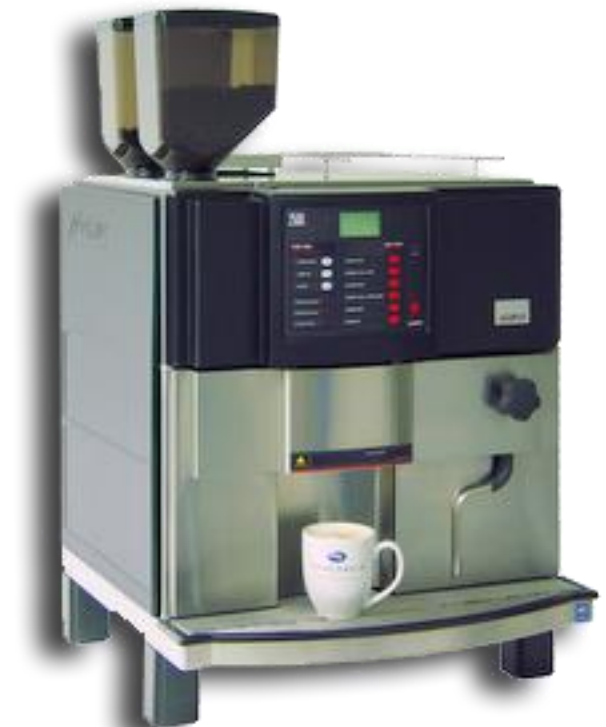
Concordia Espresso Machines

Background	
Location	Lombard, IL and Tucson, AZ.
Hardness	High
Water Usage	Low
Equip. History	Cuno systems with WAC H form resin prevented scale but caused corrosion/pitting of solenoid valve.
ScaleStop Data	
Inspected @ 6 months and 12 months.	No scale accumulation. No Corrosion
Other:	Concordia is now private-labeling ScaleStop and providing it with all of their equipment

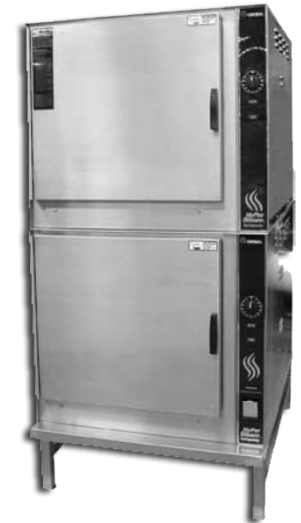
Groen Combi-oven, Model HY12YE

Background	
Location	Sheraton-Albuquerque Convention Center
Hardness	35 grain/gal 600ppm
Water Usage	Approx. 200 gpd 750 l/d
Equip. History	Chemical de-scaling required every 3-4 weeks. Annual boiler replacement.
ScaleStop Data	
Inspected @ 9 months	No scale accumulation. Boiler operating perfectly.
11 months.	Water level probe coated with crystals causing probe malfunction. The crystals were removed by wiping with a rag. Five minutes service time. 5 years consistent performance.
Other:	The service company involved calls ScaleStop the "Miracle Filter". They are now installing ScaleStop on all of their equipment.

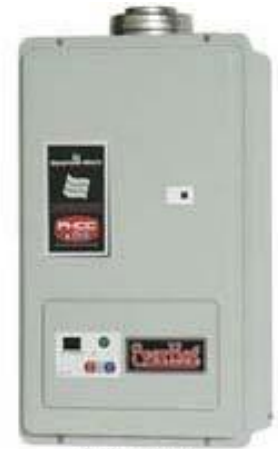
interior

Tankless Water Heaters

Bradford White/ Rinnai 199,000 BTU Commercial

Background	
Location	Middleville, MI
Hardness	28 –31 grain/gal 500 ppm
Water Usage	Approx. 200 gpd 750 l/d ASHRAE Protocol 4 people
Equip. Settings	2 Systems set at 190 degrees to accelerate testing. One Treated, one Control
Test Data	
Control unit	Drop in efficiency noticeable after one week. Complete system shut down due to scale at 2 weeks.
3 Months	Second Control unit fails after 2 weeks. ScaleStop treated system shows no measurable efficiency loss.
Ten Months	After second control unit failed in the same time period as the first. No further controls were tested. The ScaleStop protected remained operating and efficient for 10 full months in this very demanding test (22 times longer than the control).

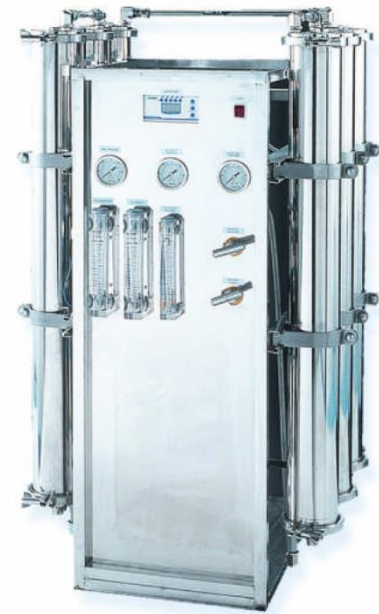
Pretreatment, El Cajon, CA

Background	
Location	El Cajon, California
Hardness/TDS LSI/Stiff Davis	15 grain / 485 mg/l .33 / .66
RO Config	6 - 4040 elements - 45% recovery Model # RO10800G-FL
Equip. History	Installed May 2006. Produces 5000 gallons of permeate per day - 18.9M ³
ScaleStop Technology Data, Dec 2006	
Permeate TDS	6 ppm, (98.7 % rejection)
Permeate Flow	6 gpm 23l/m unchanged from start- up

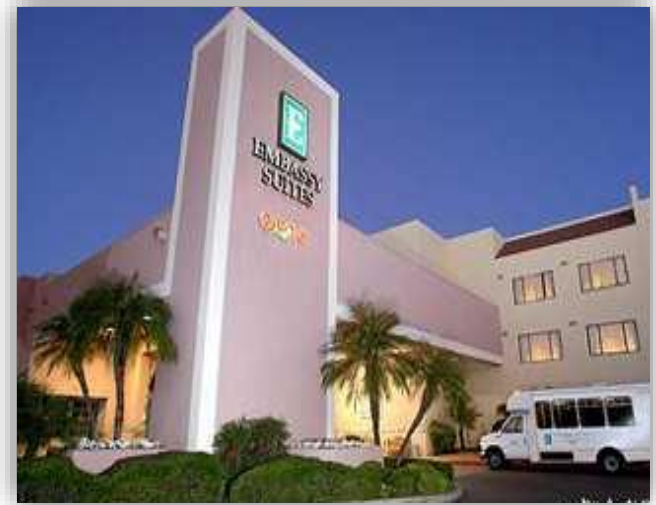
Embassy Suites Hotel

Background	
Location	Tempe, AZ
Hardness	12 grains 205ppm
Problem	Constant scale buildup led to regular boiler failures, inconvenient downtime and expensive service requirements.
Solution	The domestic hot water supply has been treated with ScaleStop for the past 6 years

After 9 months of continuous operation and no service, the chief engineer had the boiler tubes inspected.

Quote from service company. "Boiler tubes were spotless, 100% free from any scale deposits."

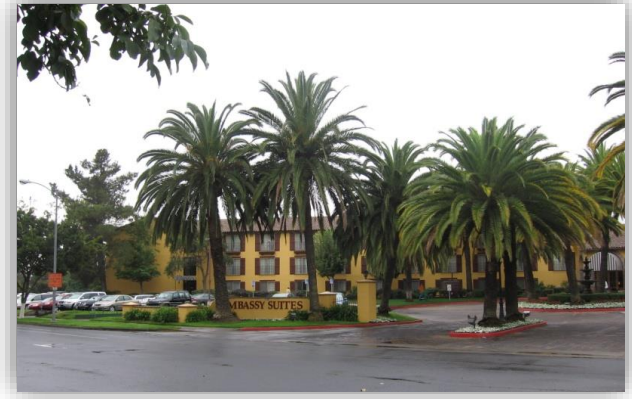
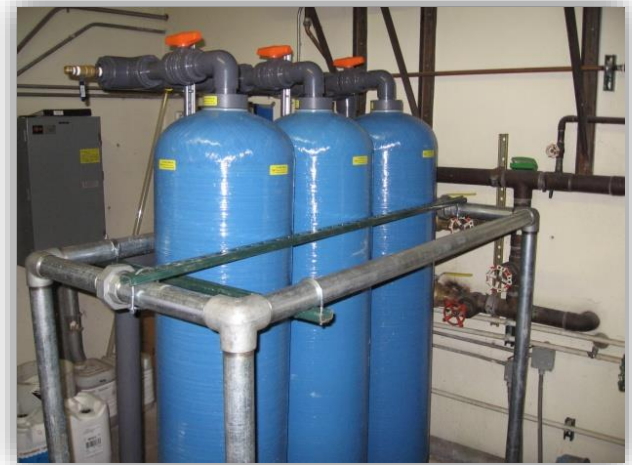
Embassy Suites, 205 Rooms

Background	
Location	Napa, CA
Hardness	5 grains 86ppm
Problem	Water Softener, Hot only, failed. Needed Replacement.
Test Info	Decided to install economical Next-ScaleStop on domestic water supply. After just 2 months, Chief engineer said that old calcium scale deposits in guest room sinks and faucets were dissolving and for first time remaining clean.

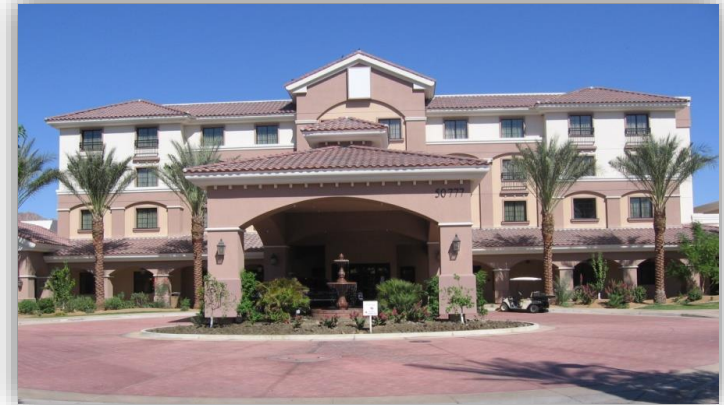
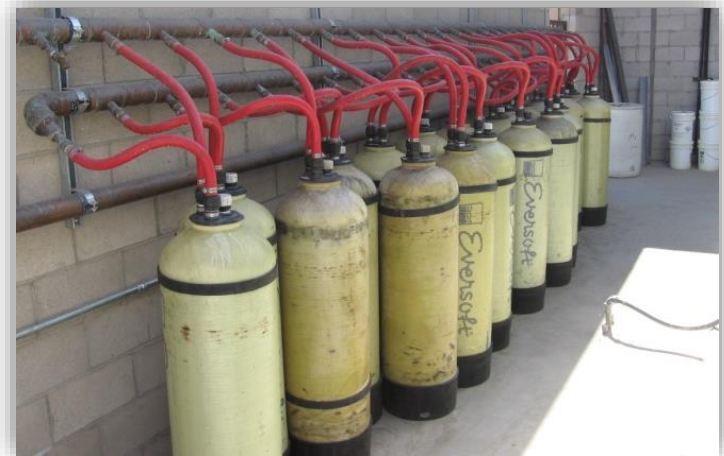
Embassy Suites 146 rooms

Background	
Location	La Quinta, CA
Problem	Commercial Softener Ban
Before Opening	22 Exchange tanks required changing 2 X month. \$1200+
Decision	Ordered ScaleStop system for entire water supply. Substantial savings and Regulatory compliance

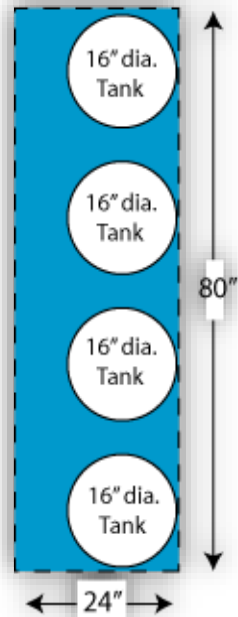
TAC System
(4) 16x65" Tanks

13.33 ft ²	None	Zero	None
Softener	88.00 ft ²	64,285	\$7,713	10%

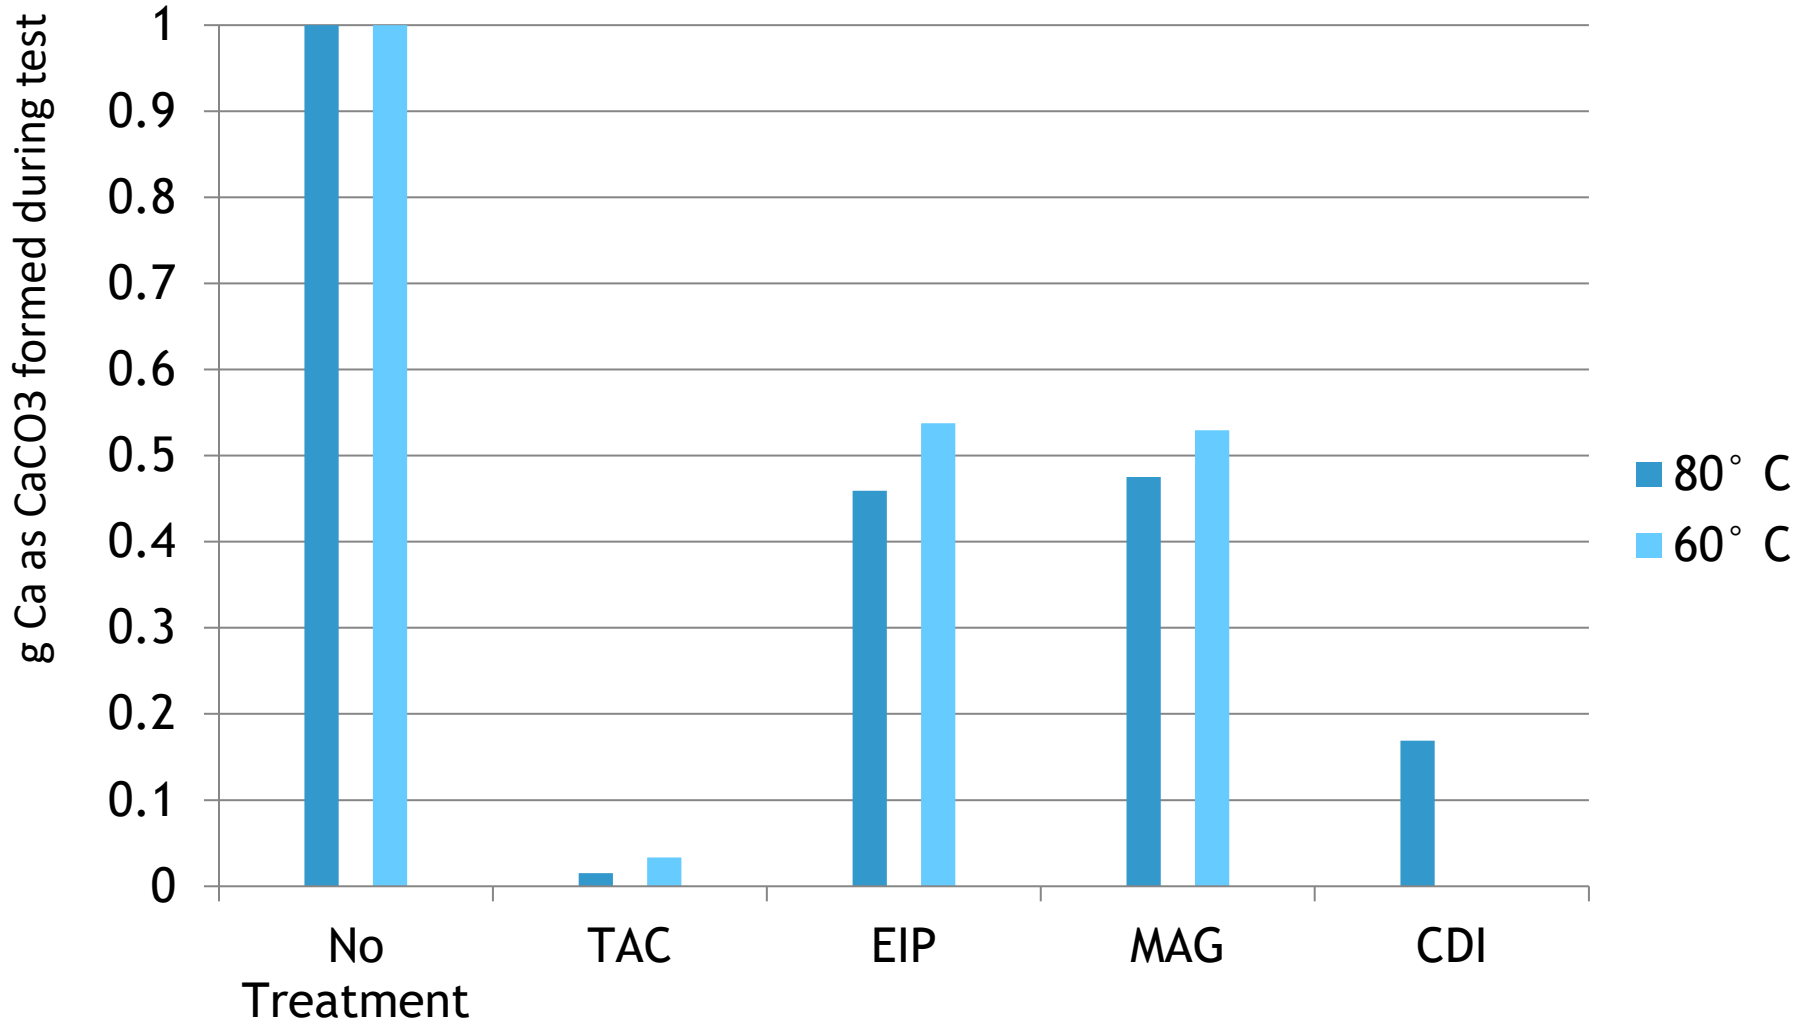
Scale Collected for Tempe Tap Water Tests

- Next ScaleStop Template Assisted Crystallization worked best, 97%+
- Capacitive Deionization worked well enough to pass DVGW test
 - Both Electromagnetic treatment and electrically induced precipitation reduced scale formation but not enough to pass any reasonable test.
